Navajo Abandoned Uranium Mine

Site Screen Report

Black No. 2 Mine AUM Site

March 2010

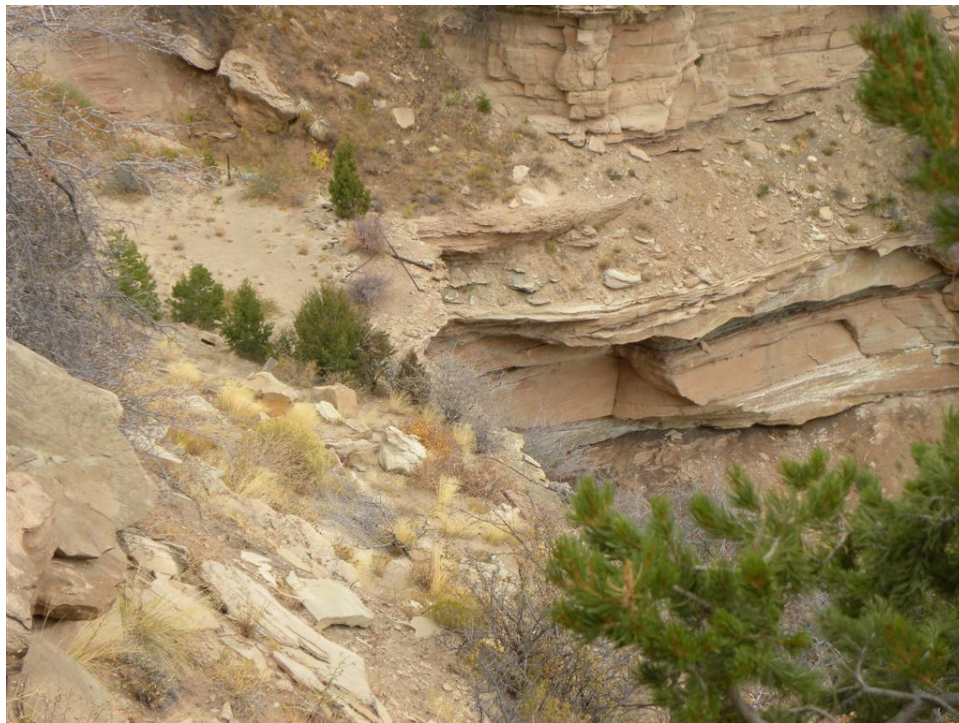
Debris extending southwest approximately 50' down canyon, 75' x 75', with a total estimated volume of 1,042 yd³

Photo 1. Waste debris off cliff side

2 inaccessible adits, one sealed, one open; unreclaimed waste pile

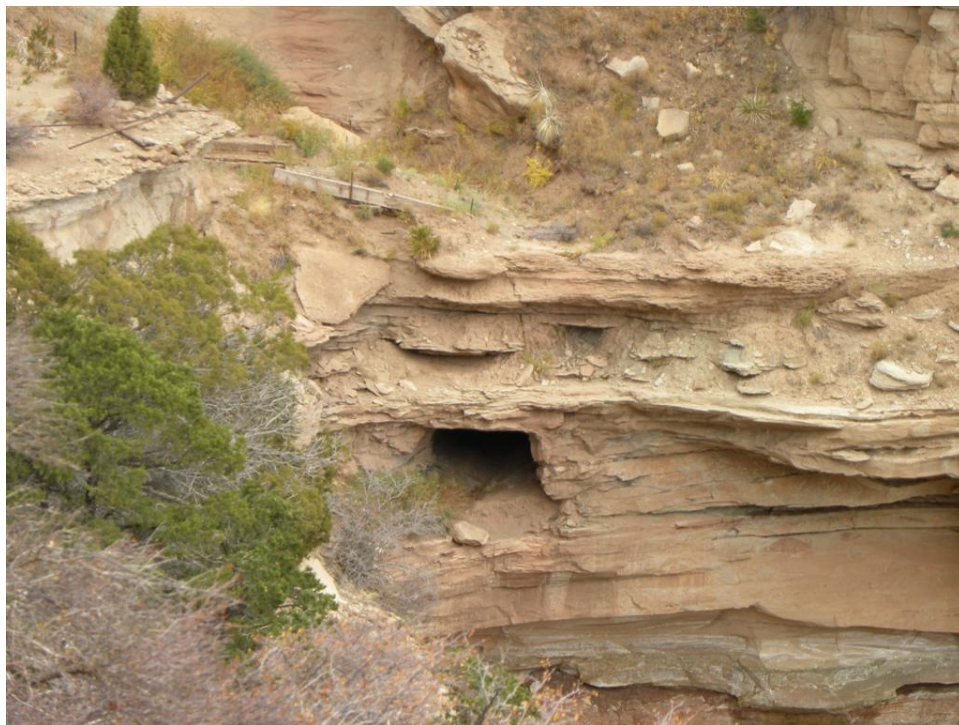
2 adits, both inaccessible: one sealed; one open

Photo 2. Inaccessible open adit

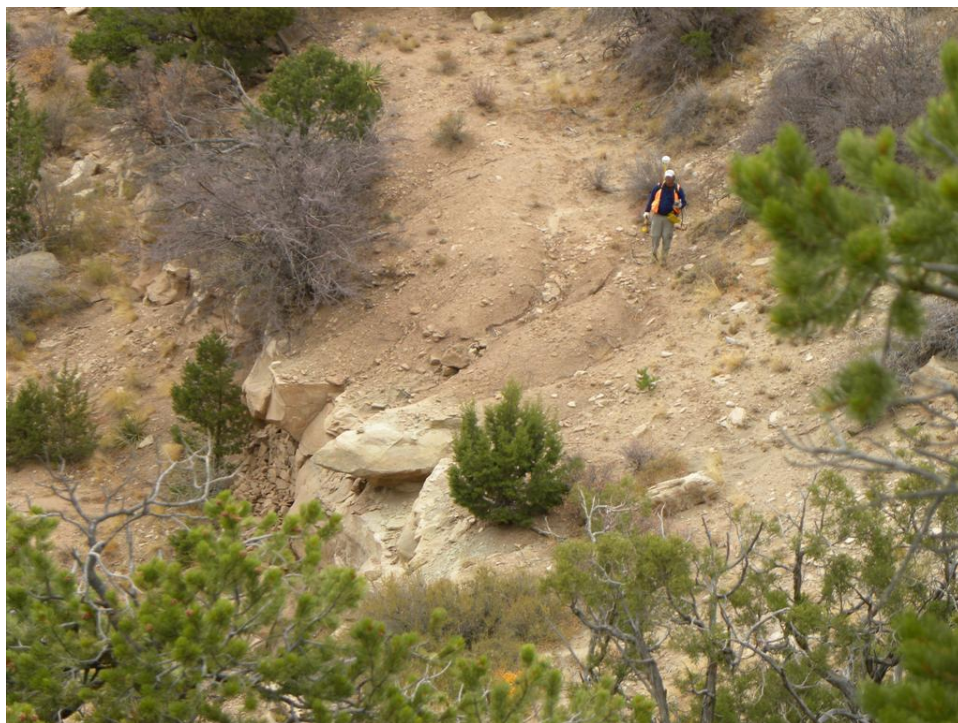
Photo 3. Mine site path

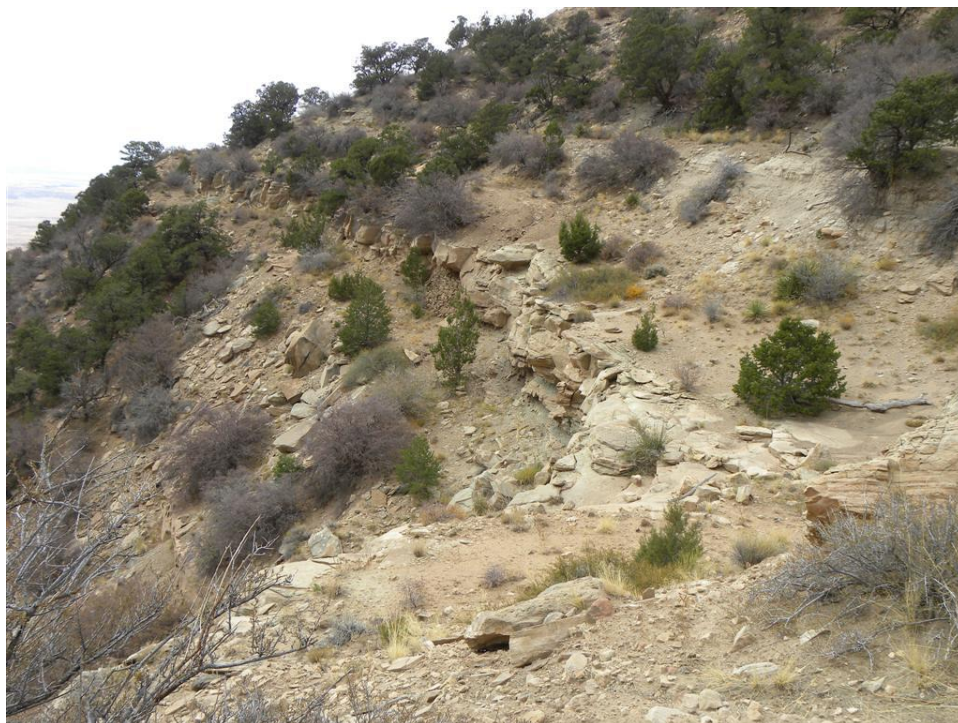
Photo 4. Steep grades downslope.
